REPORT NO. 8 (INTERIM REPORT)  
GEORGIA TECH PROJECT NO. A-680

QUARTZ CRYSTAL AGING EFFECTS

By R. B. Belser and W. H. Hicklin

Engineering Experiment Station  
GEORGIA INSTITUTE OF TECHNOLOGY  
Atlanta, Georgia

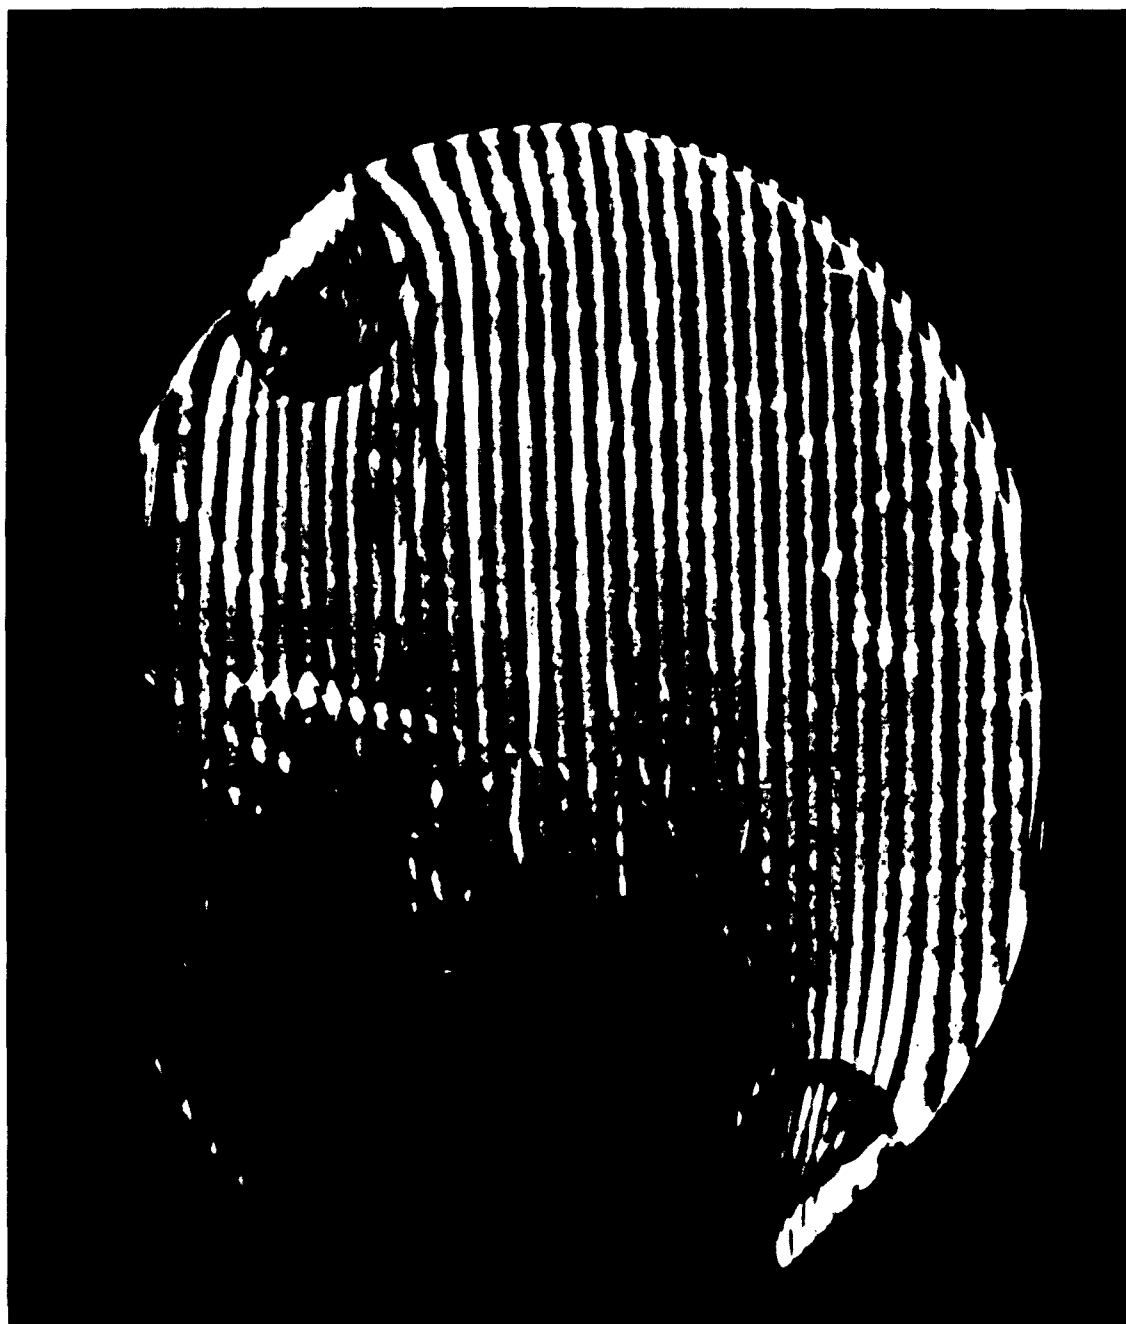
Figure 30. X-ray diffraction SID pattern of 10 Mc resonator A-8 before etching, ( $2\bar{1}0$  reflection.)

A  $2\bar{1}0$  diffraction pattern of unit A-8 is shown in Figure 30. Since there was some probability that much of the defect structure was due to surface damage incurred during preparation, the unit was etched in an ammonium bifluoride solution for 60 hours. The  $2\bar{1}0$  pattern made after this etch is shown in Figure 31. Thus, it is seen that a considerable amount of surface damage may (and, no doubt, usually does) occur during the manufacturing process.

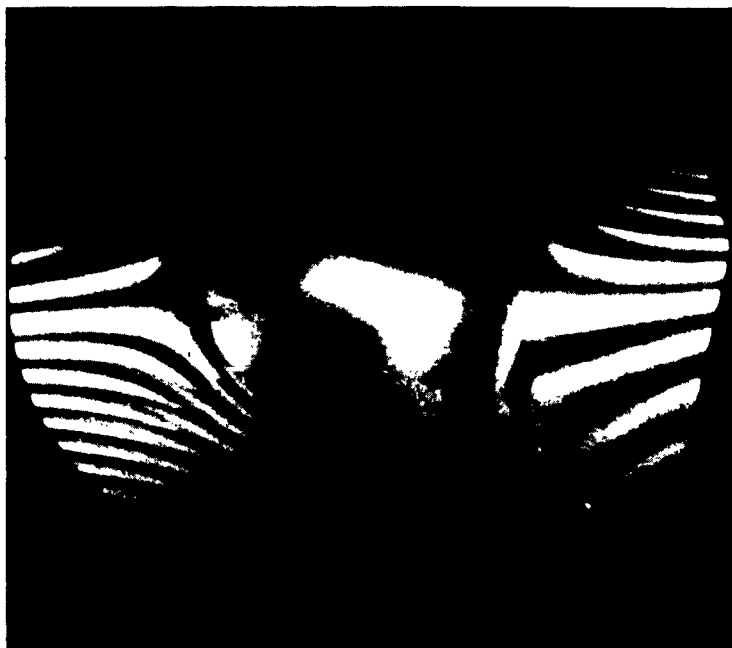
QUARTZ BLANK PLATED ON ONE SIDE

to another specimen (Figure 33), the quartz plate resembled a small concave mirror with a radius of curvature about 25 cm. Thus it is seen that plating, and/or the plating process, produces a strain on the quartz blank even with relatively thin platings, and often produces extreme strains with very thick films.
